## Introduction

## A Case Study

This home was coated with gloss solvent based polyurethane approximately four years prior to viewing this floor and the ghosting was first noticed about two years after occupancy. The upper level floor was coated about two weeks after the lower level floor. On the upper level ghosting is present in just one place, at the entrance to the ensuite of the master bedroom. Due to the design of the dwelling, this area of the master bedroom outside the ensuite would have been coated first, before the rest of the bedroom and also before other areas of the upper level floor. Therefore, it suggests a contaminant may have come from the ensuite.

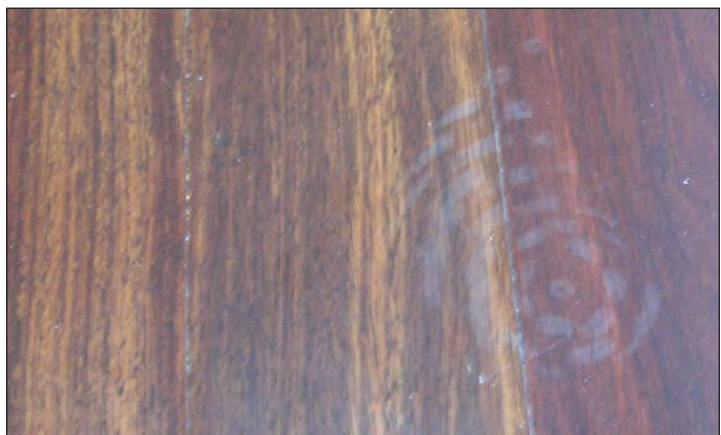
The only area of ghosting on the upper level was adjacent to the ensuite. Due to the location, this area would have been coated first and all of the floor would have been walked on to get to this area. Has a contaminant come from the ensuite, an area that was tiled/marbled some considerable time earlier? Notice that the mark is across two boards and the twisting of the foot.

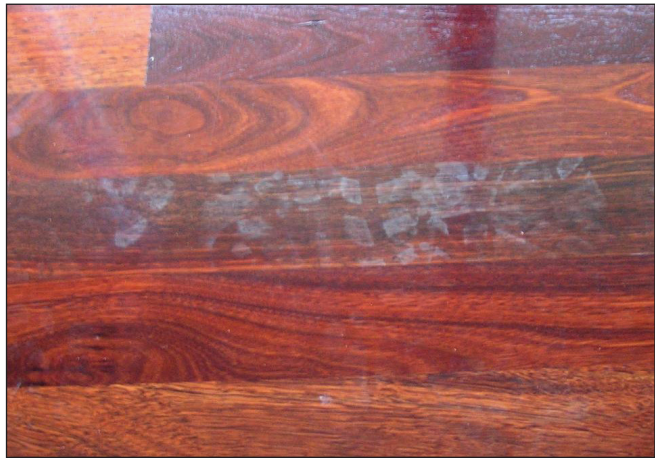
Prints mainly confined to one board and not adjacent boards. Does this suggest that the board or the drying of the sealer or coating on that board had an influence?

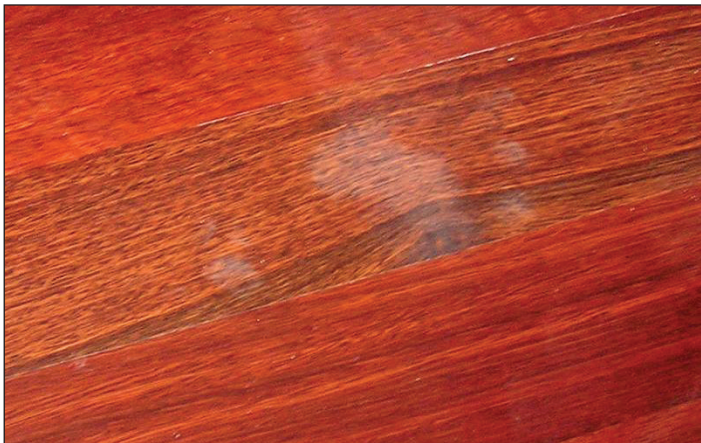
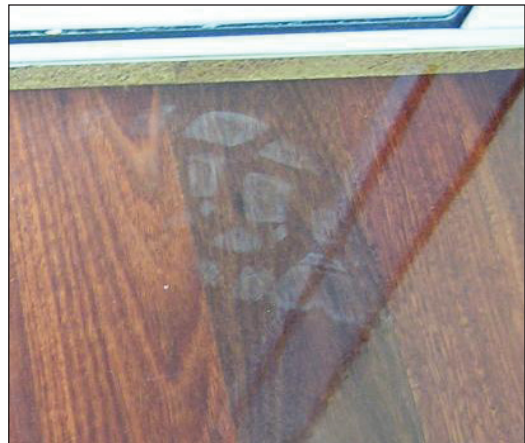
Bare foot print in the lower left photo. However, there were possibly only two or three bare foot prints discernable over the whole floor. The photo on the lower right shows a different style of boot mark at one of the patio doorways in the lounge.

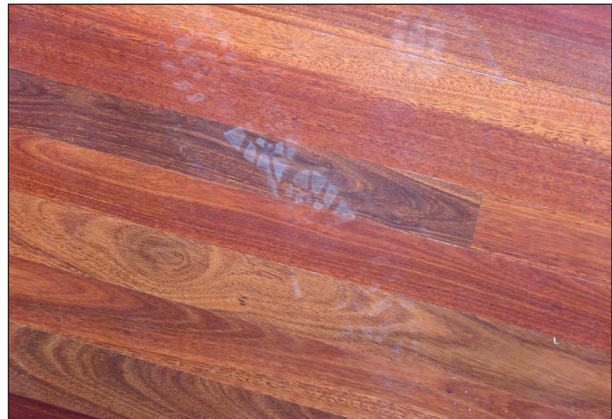
Highly developed prints in the main entrance and note the predominance in one board but also progressing into adjacent boards. Note also the two heel marks facing opposite directions. It appears to have resulted from the person simply walking in and out of the dwelling.

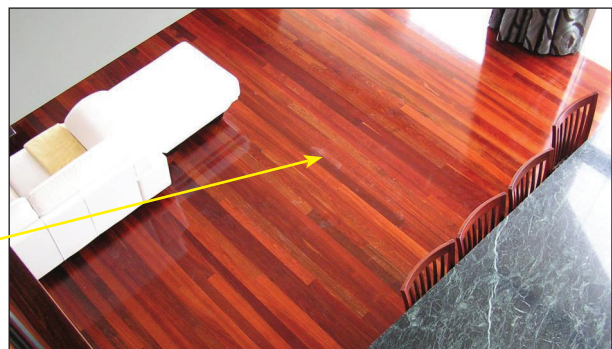
This is the lower storey lounge floor with the photo taken from the upper level. A highly developed boot print as shown in the inset is present in the middle of this floor. Note how areas either side of this area are not affected to a significant degree.

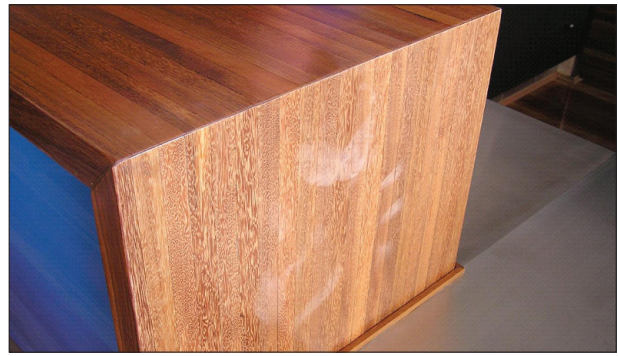
Associated with the adjacent photo, the floor was sanded and finished after ten or so years of use. The bench shown in the photo, also coated ten or so years earlier, but not part of this refurbishment, it had a plastic drop sheet placed over it and after the floor was finished and the drop sheet removed, these hand marks became immediately apparent on the bench.

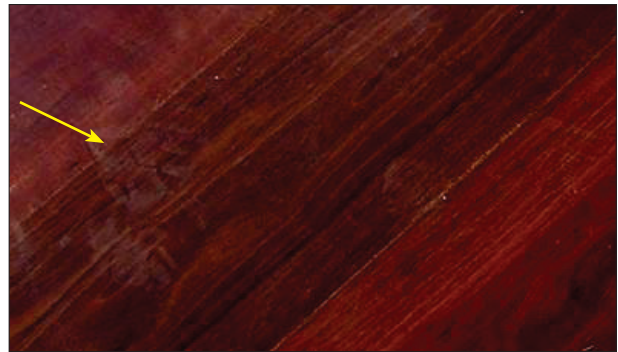
In this dwelling the coating had been down for two years. The family dog killed a possum that had come into the house and after this, the ghosting shown here appeared over the following months. Note the shoe print arrowed.

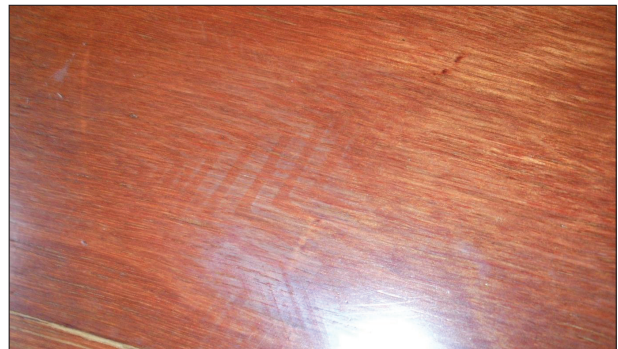
This mark was reported to have appeared soon after the floor was recoated seven years after initial coating.

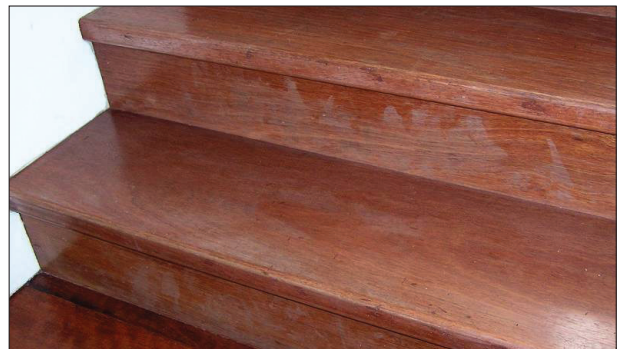
Ghosting does not always appear as foot prints and it does not always appear on horizontal surfaces. In this final example the ghosting appears more predominantly as smudging in the stair risers. In other instances boot prints have been observed in stair risers.
