## Introduction

This information sheet outlines reasonable owner expectations for onsite sanded and coated timber floors, which generally applies to solid T&G flooring and parquetry. Concerning floor acceptability, there are performance aspects of the floor which can relate to fixing integrity, board shape and movement, and then there are appearance aspects which focus more on the sanding and finishing. The sanded and coated appearance aspects of this information sheet will also be applicable to some other flooring types (e.g. engineered flooring that receive site sanding and coating). Although an imperfection free floor is the desire of any tradesperson, it is the process of installation and finishing where the environment and other conditions cannot be fully controlled that moves the completed job to one that is 'normal' and of a commercially accepted standard. This however is not to say that the completed floor won't be of a high standard and well suited to its purpose as a floor, which is to be walked on, but it does acknowledge that the finished product will not be the same as fine furniture and that due to seasonal influences and heating and cooling, that some movement refle

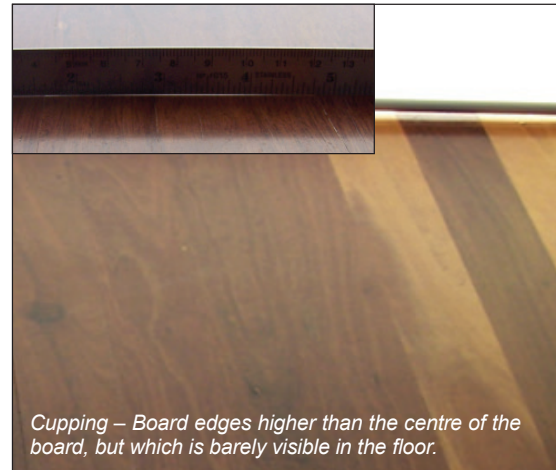
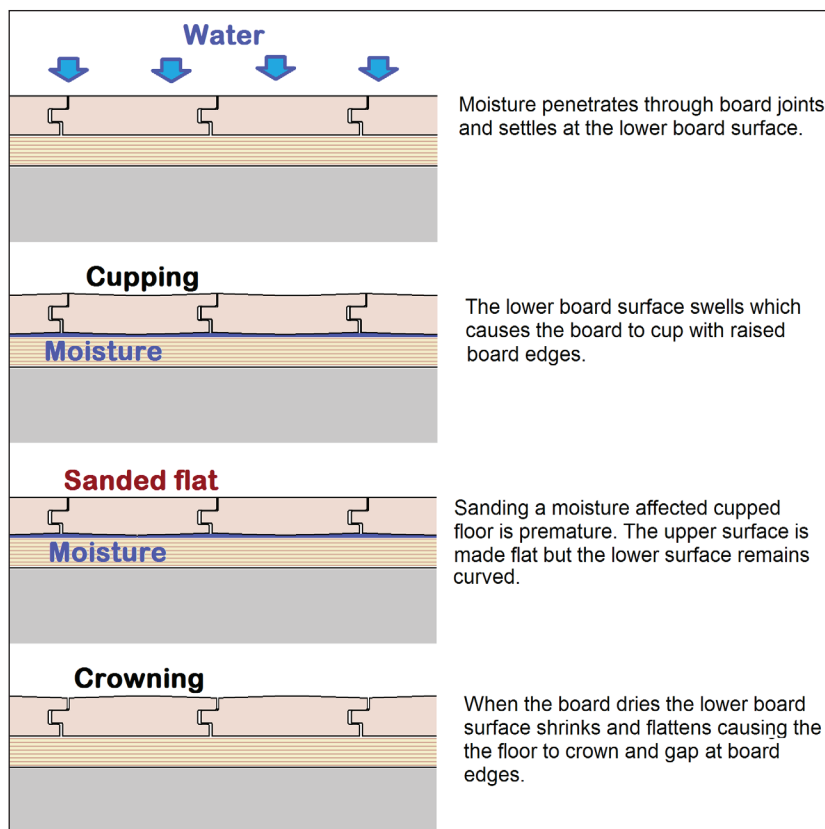
- **Cupping** – boards with their edges either higher or lower than the centre of the board. Heat in a specific location or a very dry environment above the floor may result in cupping. Moist subfloor spaces can also cause boards to cup. Cupping is more likely to be observed in overlay flooring and standard thickness boards that are wider than 100 mm. To some degree a small amount of observable cupping may occur in some locations within a dwelling (e.g. sun exposed floor) where these types of flooring are used.

- **Peaking** – this has the appearance of cupping but is the result of expansion pressure in the floor.
- **Tenting** – two adjacent boards, where the adjoining edge has lifted above the level of the adjacent flooring. This is often associated with high moisture beneath the floor and can be from many causes.

- **Buckling** – a section of flooring containing a number of boards that is raised above an adjacent section.
- **Crowning** – floorboards that are flat on their lower surfaces but where the upper surface has its edges lower than the centre of the board. Crowning in timber floors occurs when a floor has become wet, has cupped and then is sanded prematurely before the moisture imbalance between the top and bottom of the board has balanced out. Crowning does not become apparent until some months after finishing.

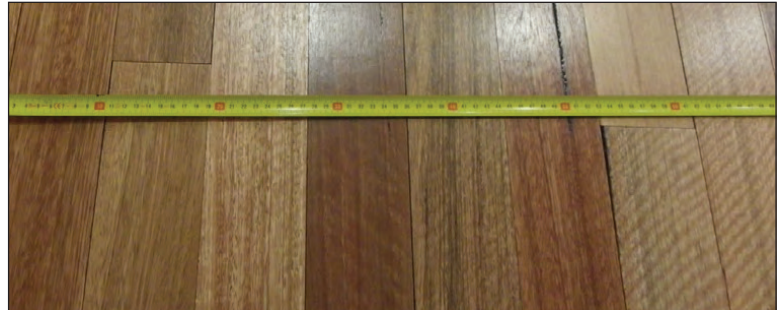
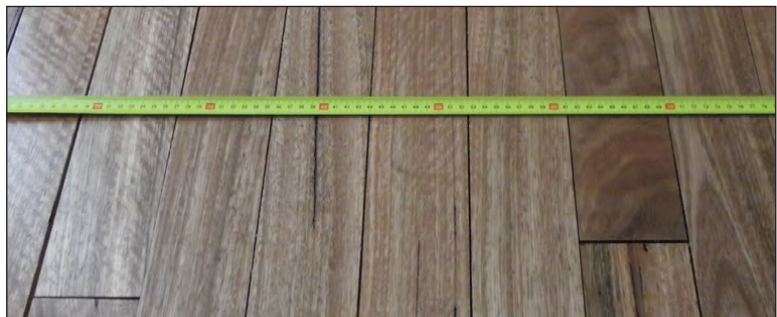
The first photo which is considered acceptable, has gapping near the upper limit where the average gap size was 0.75 mm and the second photo has gapping that is not considered acceptable where the average gap size was 1.8 mm. Note that it is the average gap size over 10 boards so some gaps are greater than the average and other less than the average.

With solid timber strip flooring shrinkage gaps over 10 boards can average 0.75 mm for an 80 mm wide board floor under drier internal conditions. For wider boards, proportionally wider average gapping can be expected. The appearance should indicate gapping between most boards and be free from irregularly spaced wide gaps associated with edge-bonding. The provision of expansion gaps as part of the installation process and evident throughout the life of the floor is acceptable.

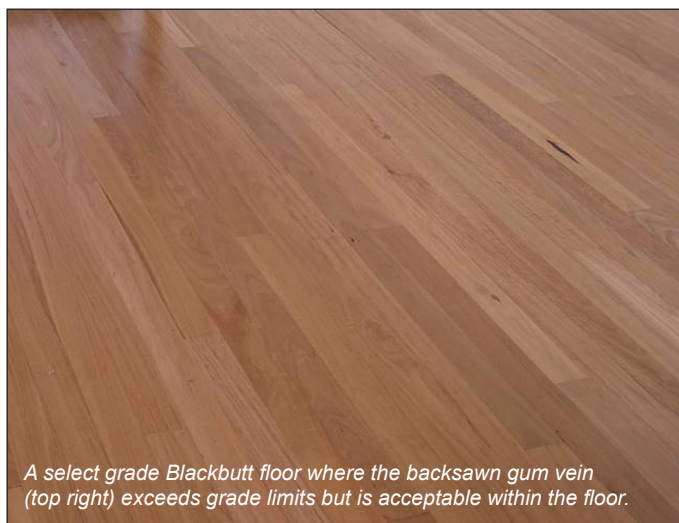
*A select grade Blackbutt floor where the backsawn gum vein (top right) exceeds grade limits but is acceptable within the floor.*

Where the number of boards in a floor that has features that exceed grade limits, in terms of size and number, are relatively few (less than 5%) and the overall appearance of the floor is in line with the chosen grade, no remedial work is considered necessary.

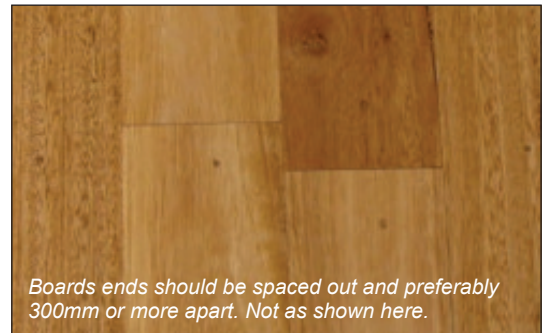
Board lengths for structural flooring (minimum 19mm thick) are generally a minimum of 900 mm long when laid on joists or battens. In structural floors boards should also span two joists or battens and only one end joint should occur in a group of three adjacent boards between floor joists or battens. When laying over a structural sub-floor the minimum length may be shorter. Where possible end joints should not cluster together or align. It is preferred that end joints be a minimum of 300mm from end joints in adjacent boards.

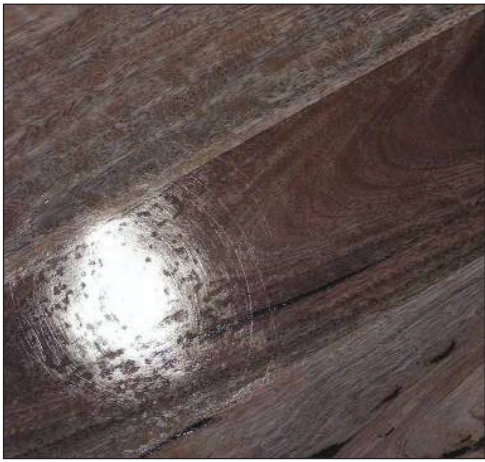
*The photo to the left shows circular swirl marks that are visible under down light. The photo to the right shows the same section of floor in natural light without the down lights on and the swirl marks are not visible.*

- **Swirl marks** – Swirl marks are caused by rotary sanders and to some degree will be present in all floors. Down lights will highlight sanding imperfections due to light refraction through the coating and as such this is not controllable by the contractor. Fine swirl marks that are not obvious under natural light when assessing a floor should not be a concern.

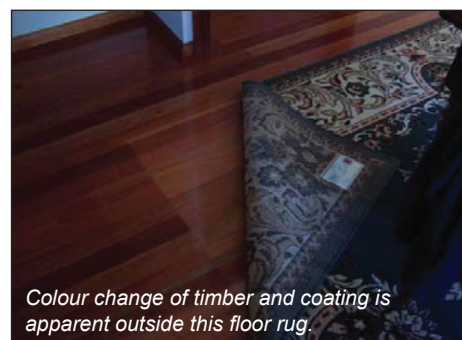
*Colour change of timber and coating is apparent outside this floor rug.*

Over the course of time colour changes occur in timber floors from the effects of ultra violet light. Therefore, it is usually more pronounced in sun exposed areas of the floor. This is partly associated with the changes in the timber and partly with the coating that is applied. Some coatings darken with time more than others and some timbers are more prone to colour changes than others. This process is natural and often gradual but can result in distinct colour differences where rugs have been put on the floor. Some of this change can be minimised by not putting rugs down till six or so months after the floor has been completed. It is beneficial for flooring contractors to make clients aware of how the coating used may result in colour differences. From there it is up to the owner to manage how rugs are used.
